SmartInnovation

Pulse Plating

DTU MEK – A.H. Nichro Haardchrome A/S

Johan Braüner Nielsen / Kristian Eg Løkkegaard
2018-08-07 / 2018-12-10

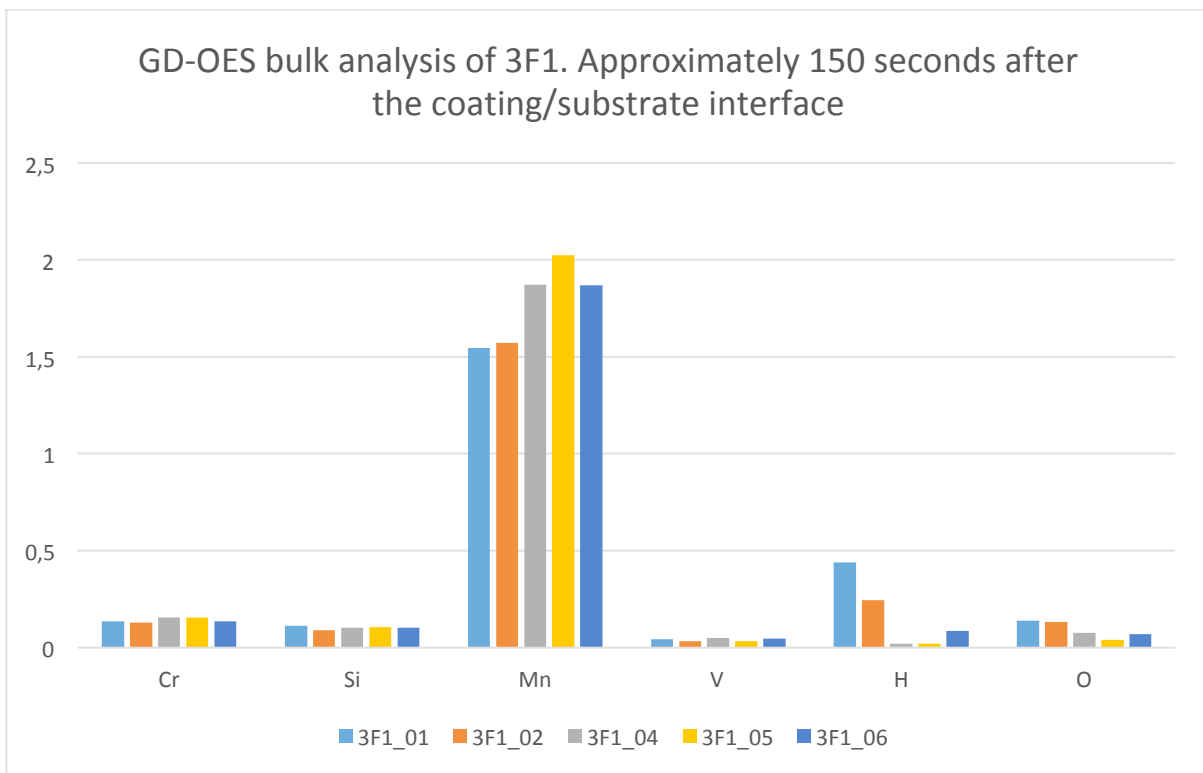
In the case of the 3F series (100% PR-plated hard chrome), several plates had previously been plated with a sole layer of pulse plated chromium. They had then been stripped and prepped before being pulse plated again. The resulting coating, 3F, however showed extremely bad adhesion to the substrate. A ring of approximately 20 mm around the edge of the plate appeared to have proper adhesion and then a relatively sharp line separated this part of the coating from the centre part that peels off very easily. An adhesion test has not been performed as it was evident the adhesion was inadequate. As plates in the 3F series, that had not been previously plated, showed no indication of similar problems it appears to be an issue with alteration of the substrate. Therefore, has the substrate been analysed using GD-OES. A few results of this are shown in Figure 16: Chart showing the contents of alloying elements (wt%) of 3F1 substrate measured using GD-OES From this it is evident that towards the centre of the plate (spot 3F1_01 and 3F1_02) there is much more hydrogen in the substrate. This appears to decrease gradually to be very limited towards the edge where proper adhesion was seen (3F1_04 and 3F1_05).

Figure 16: Chart showing the contents of alloying elements (wt%) of 3F1 substrate measured using GD-OES

DTU performed GD-OES analysis on these panels trying to describe the changes of the base material. Unfortunately they did not perform a similar analysis reference measurement on a fresh Ovako 280 panel. Thus we do not have a description of the changes in the base material caused by PR plating parameters but the GD-OES did confirm that changes took place.

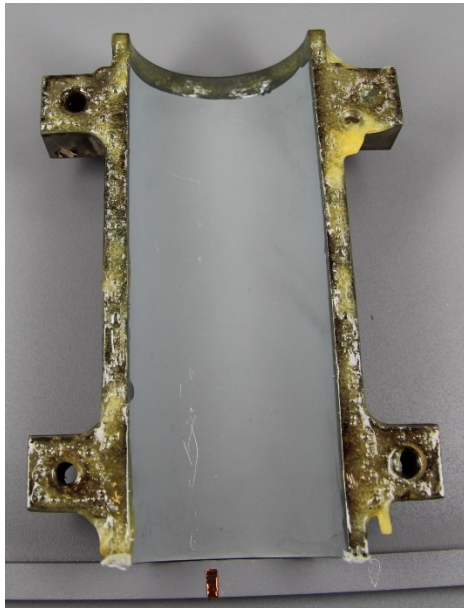
Figure 17: 3F1 prior to NSS exposure

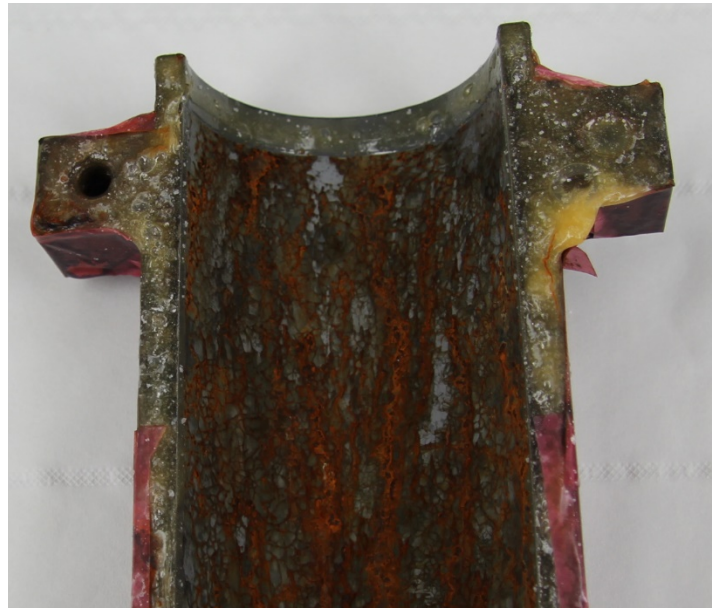
Figure 18: Zoomed image of 3F1 (PR plated) after 168 h exposure in NSS.

From Figure 18 it can be seen how the cracks in the coating has allowed the corrosive species to penetrate to the substrate and the dried-out river bed pattern is vaguely visible. Similar was seen on the plates in series 1F (100% PR). The performance of the combined layers of the D and E series (DC with 2 → 6 PR layers) were inadequate in comparison to that seen before in the 2008 - 2010 tests. At that time the samples were stopped after 504 h of NSS with no sign of corrosion. The difference between these tests was the current density and the adhesion procedure. It seems that the current density in the plating process affects the substrate irreversible if it is too high, (photo below).

The few but large cracks of sample 56 (1F series – solely PR hard chrome) coincide with the dried-out riverbed pattern seen after the salt-spray testing. This bleeding from the cracks indicates that these fewer but wider cracks go all the way through to the base material. Thus fewer cracks itself are not necessarily preferable if these go straight through the coating and reach the base material. The base material itself is steel of the type Ovaco 280 containing manganese in the surface. It might be so that the manganese is involved in side-reactions forming stable compounds preventing further plating. If this is the case it indicates that the base material itself affects the properties of the hard chrome.

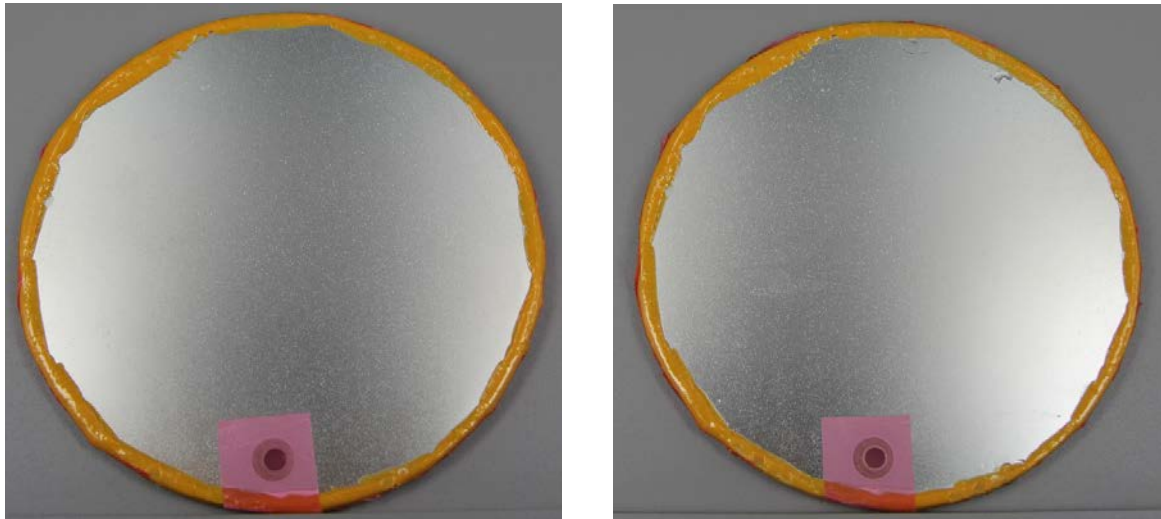
Figure 19: 5DB3 (DC with 2 PR layers) prior to exposure (left) and after 672 h NSS exposure (right)

Figure 19 shows how the 5DB series (both 5DB2 and 5DB3) has been able to resist corrosion for 672 h – only 5DB1 showed 2 spots of corrosion after this time. Furthermore, 5DB2 and 5DB3 has been able to stay corrosion free for up to 766 h. Unfortunately the salt-spray chamber broke down at that time. This is a significant improvement over the previous panels of the D type. Below in Figure 20 is seen 3D4 before and after 720 h of exposure in NSS and it is clear how the altered initiation of 5DB improves the corrosion properties over the 3D series and its ramp-up initiation method.

We did succeed to produce hard chrome coatings being able to withstand the salt-spray test for more than 750 hours (3C5 and 5DB series). The coatings in the 5DB series are DC plated hard chrome with 2 PR chrome layers build in as designed. These coatings are fairly identical to the coatings produced at Nichro in 2009 withstanding the salt-spray test for more than 500 hours. The activation procedure however might not be the same.

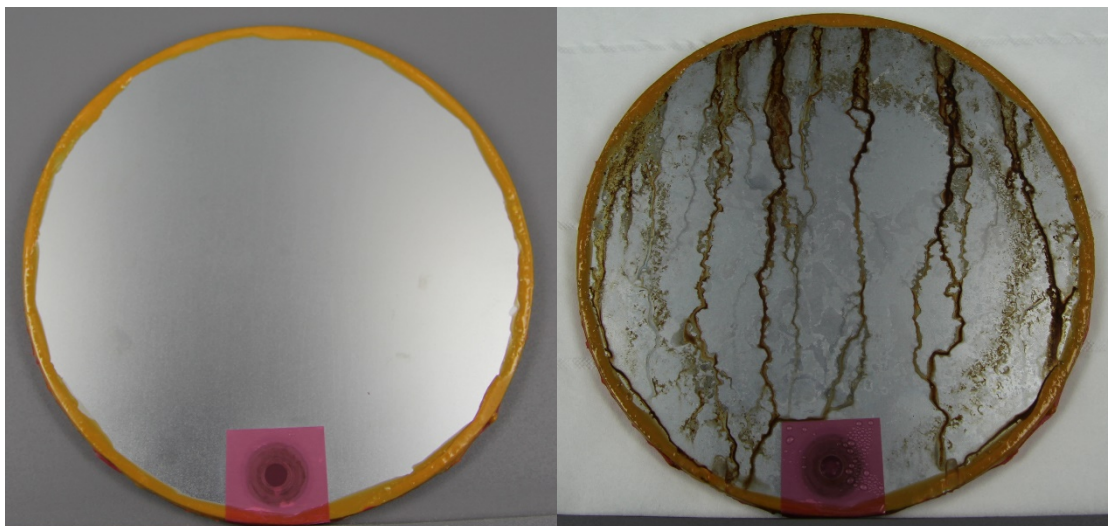
Figure 20: 3D4 (DC with 2 PR layers) before NSS exposure (left) and after 720 h exposure (right)

The 3D series is however still better than the 1D series (DC with 2 PR layers) that had both ramp-up initiation and high current density for the pulse plated layers. It is worth mentioning that a plate from the 3C series has managed 1016 h exposure in NSS without corrosion (fig.21). This series was manufactured with very low current density. However, it shall be mentioned that 3C4 did not last this long and started showing corrosion after 336 h.
